Manhole Inspection Summary

Manhole # S23K1_002MH

Inspection ☐ Is Incomplete Rating: **4) Poor**

Location Address: **2933 Rayshire Rd.**

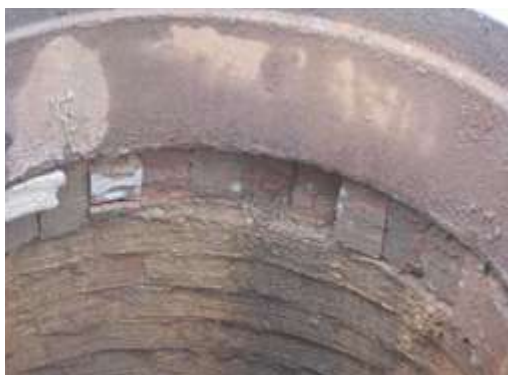
Defect 7

Condition: ☐ Sound ☐ Cracked ☐ Root Intrusion ☒ **Loose Brick** ☒ **Deteriorated**

Infiltration: ☐ None ☒ **Joint** ☒ **Cracks** ☐ Mortar ☐ Roots ☒ **Wall**

chimney deteriorated & loose bricks with infiltration from joint, cracks & wall

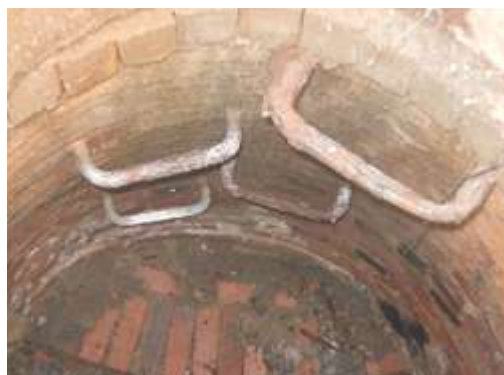
Defect 6

Count: **4** Missing: **0** ☒ **Corroded**

corroded steps

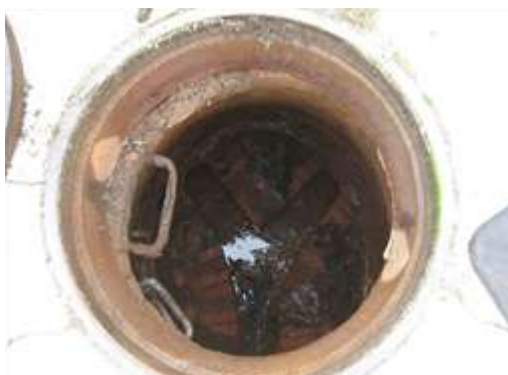
Defect 5

Offset: **3** (in.)

frame offset

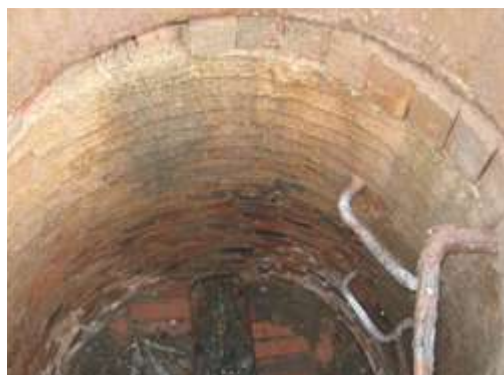
Defect 3

Infiltration: ☐ None ☐ Joint ☐ Cracks ☐ Mortar ☐ Roots ☒ **Wall**

corbel wall infiltration

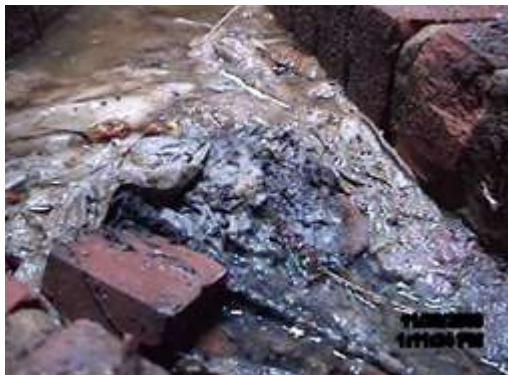
Defect 1

Condition: ☐ Sound ☐ Cracked ☐ Root Intrusion ☐ Deteriorated ☐ Leaks ☒ **Debris**

heavy debris in the channel

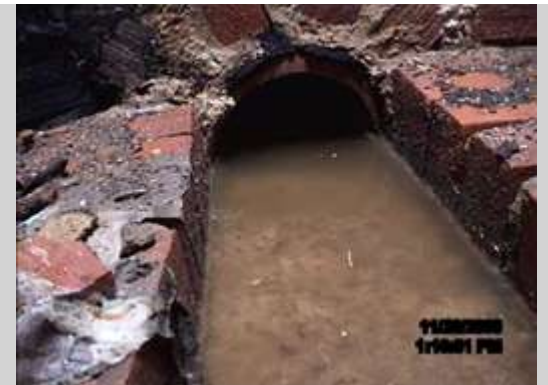
5 O'Clock Inflow

Pipe Height: **6** (in.) Rod and Bar (Angled)
Pipe Material: **Clay** ☐ Pipe Lined
Invert Depth: **7.51** (ft.) Flow Characteristics: **None**
Deposits: ☐ None ☐ Mud ☐ Sludge ☒ **Debris** ☐ Grease
Silt Depth: **5** (in.) Deposits Extent: **Heavy**
Infiltration: **None** Pipe Seal Cond: **Sound**

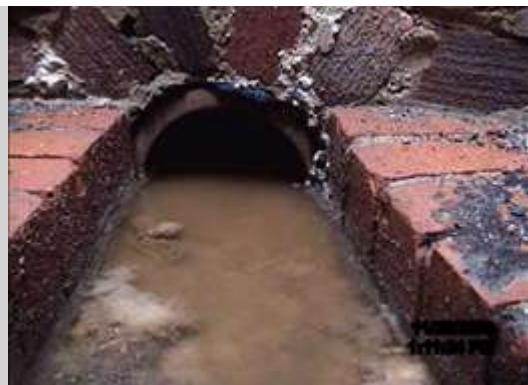
7 O'Clock Inflow

Deposits: ☐ None ☐ Mud ☐ Sludge ☒ **Debris** ☐ Grease

Silt Depth: **3** (in.) Deposits Extent: **Medium**
